## **Performance of masonry structures during the 2009 L'Aquila (Italy) earthquake**

KAPLAN, H.<sup>1</sup>; BILGIN, H.<sup>2</sup>; BINICI, H.<sup>3</sup>; YILMAZ, S.<sup>4</sup>; OZTAS A.<sup>5</sup>

**Keywords:** L'Aquila earthquake, unreinforced masonry, historical buildings, failure, collapse.

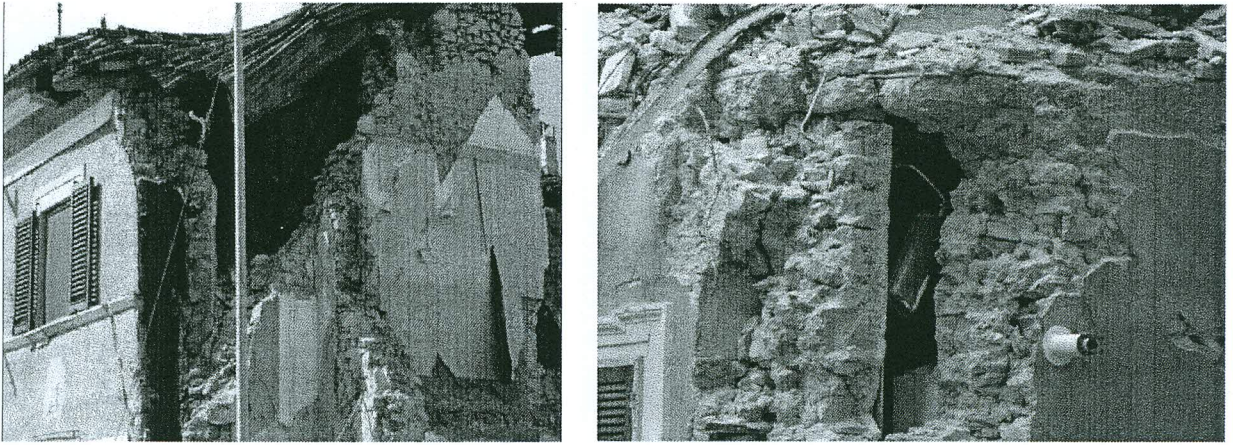
In many of the damaged buildings, there was a total absence of anchorage of the floors, corners and roof to the walls. In the absence of anchorage, the exterior walls behave as cantilevers over the building height. Even though it is true that some friction force exists at the supports that may prevent failures in low range of earthquake excitation, the resistance between them is supposed to be small and negligible. Lack of anchorage resulted in failures in many buildings (Figure 3).

**Figure 3.** Failures due to the absence of anchorage between cross walls

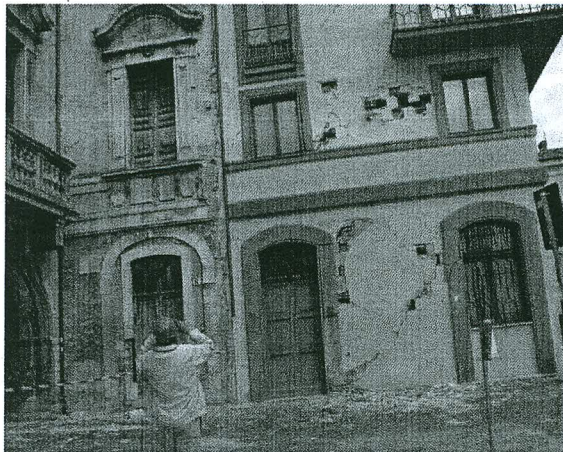
For URM walls, shear in plane failures are common expressed by X (double-diagonal) shear cracking. Excessive shear or bending produced in-plane failures in many old buildings in L'Aquila (Figure 4a). In masonry facades where numerous window openings, spandrels and the short piers failed in shear (Figure 4b).

**Figure 4.** a) In-plane shear failure of URM walls ; b) In-plane shear failure of URM pier

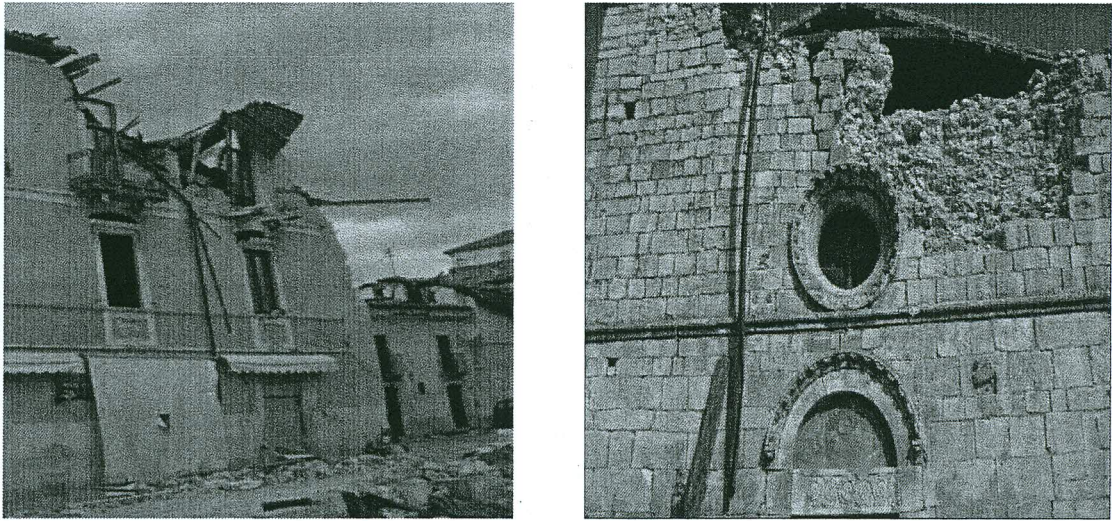
Beam-to-wall anchors provide out-of-plane supports to the walls. Due to the absence of sufficient strength, many of the URM buildings were most vulnerable to flexural out-of-plane failures. These kinds of failures were observed in many buildings and the gravity-load-carrying capabilities of these walls vanished (Figure 5a). Double-layer URM walls constructed with sandwiching insulation performed poorly as well: the presence of insulation prevented bond between the layers and resulted in out-of-plane failures.

Especially in historical monumental buildings, parapet failures were observed. These non-structural elements behaved as cantilever walls extending beyond the roof line, located at the top of the buildings. Generally gables of churches and similar buildings improperly anchored the roof and behaved like parapets (Figure 5b).

**Figure 5.** a) Out-of-plane failure of URM top-story wall ; b) Parapet failure of a historical building

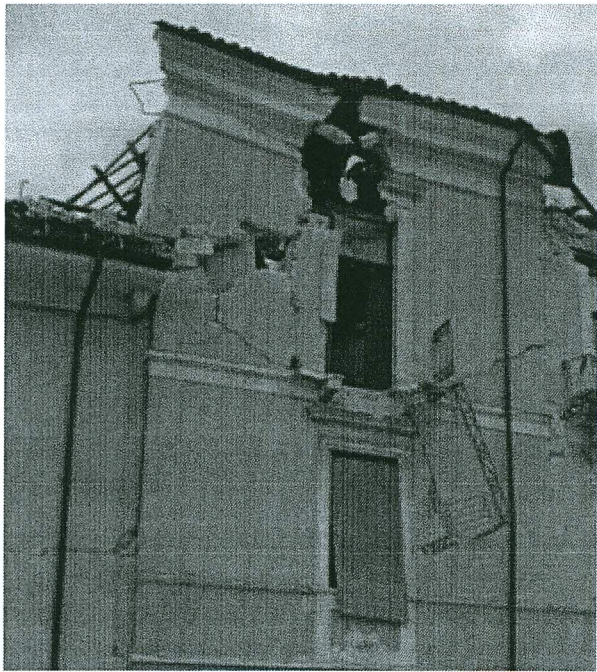
Pounding against adjacent structures caused failures (Figure 6).

**Figure 6.** Pounding-induced failure
