Performance of Masonry Structures During the 2019 Durrës (Albania) Earthquake

Keywords: Durrës Earthquake, unreinforced masonry, failure, collapse

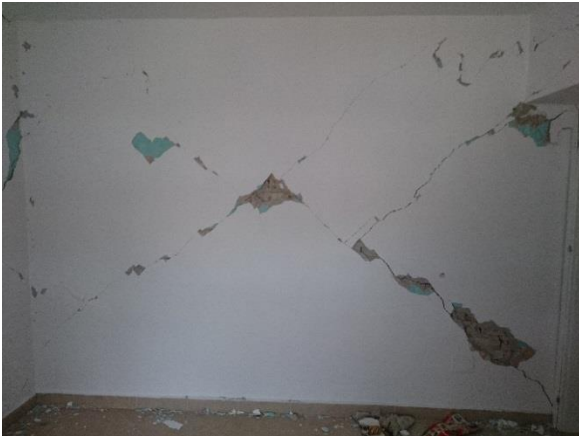
In many of the damaged buildings, shear in plane failures were common expressed by double-diagonal shear cracks. Excessive shear or bending produced in-plane failures in many old buildings in Albania (Fig. 1.).

Fig. 1. In-plane shear failure of URM walls

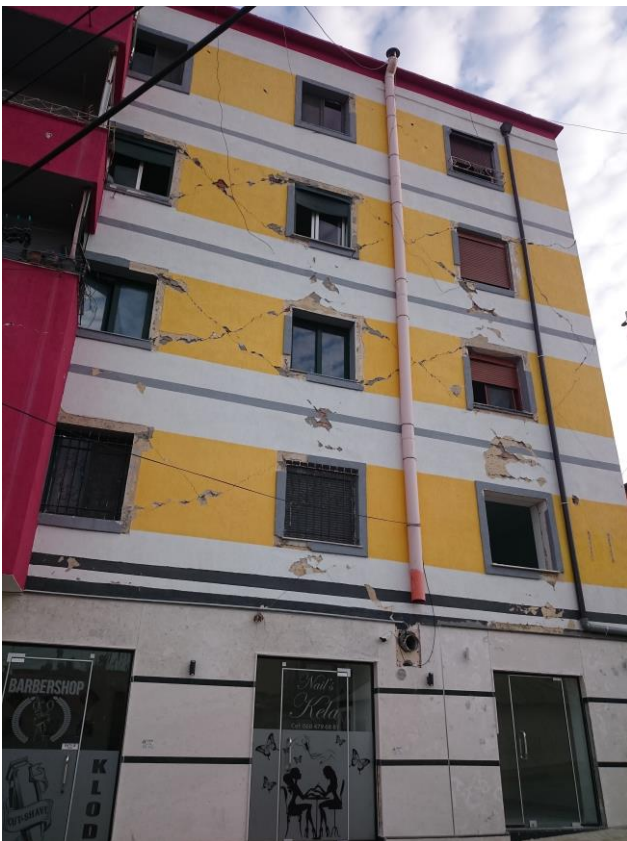
In masonry facades where numerous window openings, spandrels and the short piers failed in shear (Fig 2.).

Fig. 2. In-plane shear failure of URM piers

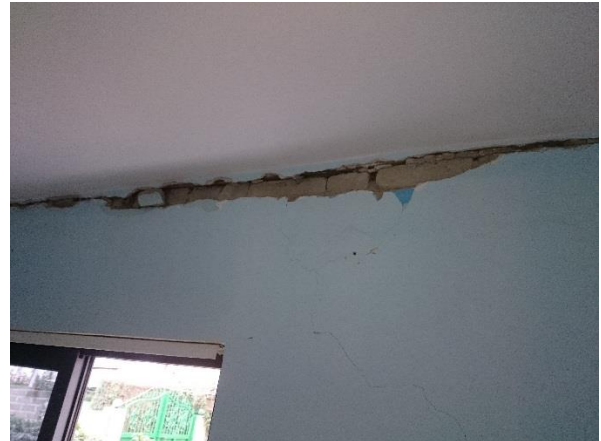
In the absence of anchorage, the exterior walls behaved as cantilevers over the height of the buildings and resulted in failures in many buildings (Fig.3.).

Fig. 3. Failure due to the lack of proper anchorage

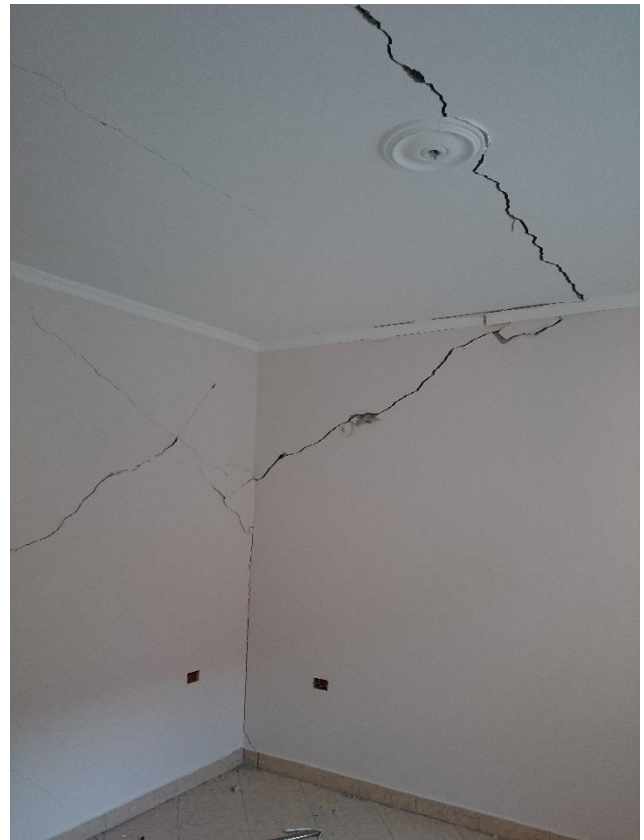
Another observed damages on URM buildings were occurred due to the lack or rigid diaphragm actions (Fig. 4.).

Fig. 4. Diagram related failures

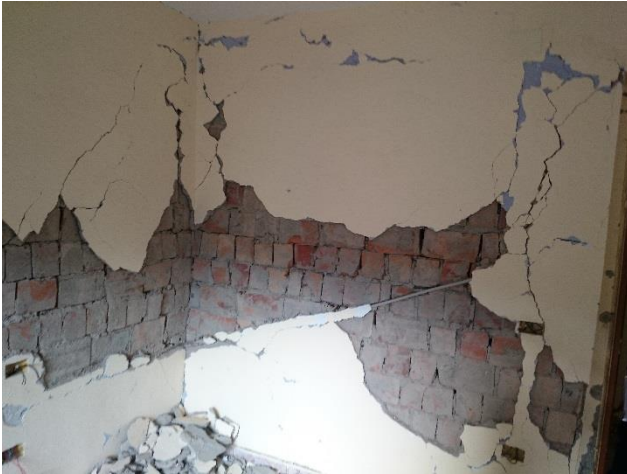
Material quality induced failures were also common in many masonry buildings (Fig. 5.).

Fig. 5. Poor material quality and workmanship induced failures
