Seismic performance assessment of a typified school building damaged during the 2019 Albanian earthquakes

To cite this article: Marjo Hysenlliu and Hüseyin Bilgin 2020 IOP Conf. Ser.: Mater. Sci. Eng. 989 012030

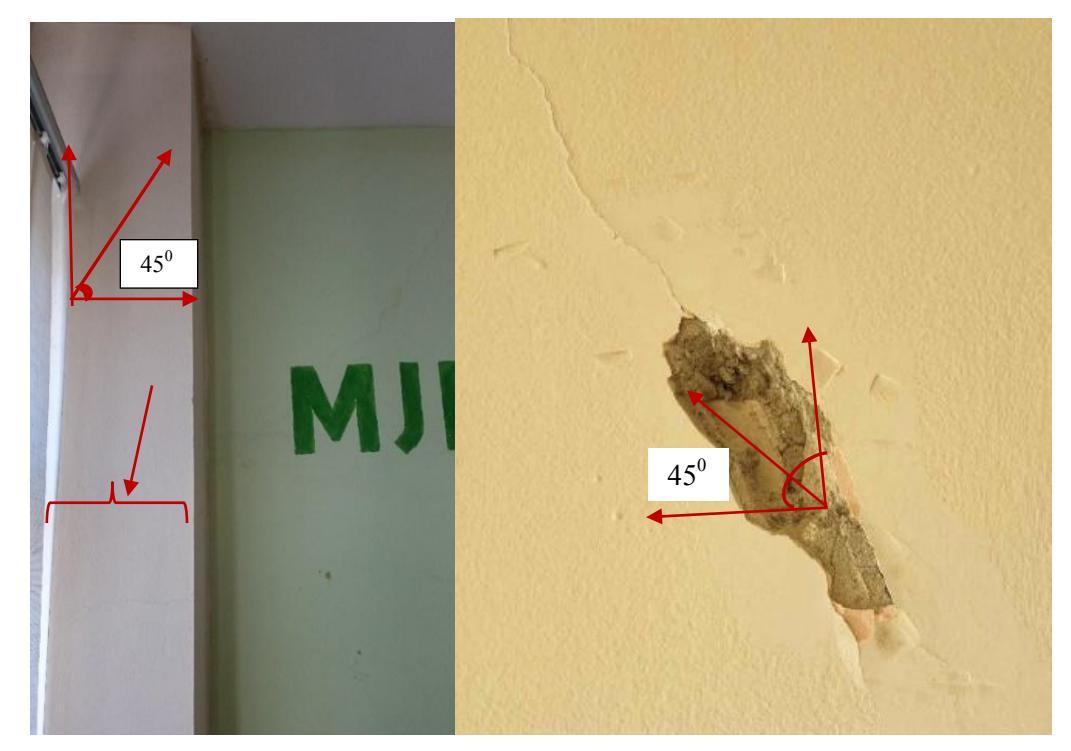
Figure 6. Damage on pier element on the corner and typical shear crack on the load-bearing wall.

During the inspection inside the buildings, a considerable damage was observed on the main building walls. We observed a 450 inclined shear crack on a number of walls on the ground floor (Figure 6.). These structural cracks were formed on the 45 cm thick wall, which was subsequently

removed in the upper floors to make additional space, occurred during the Durres earthquake of 26 November 2019.

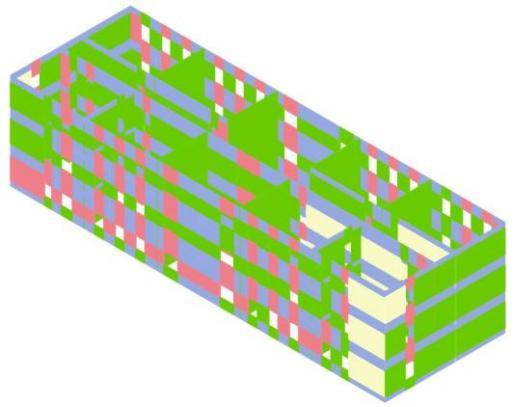
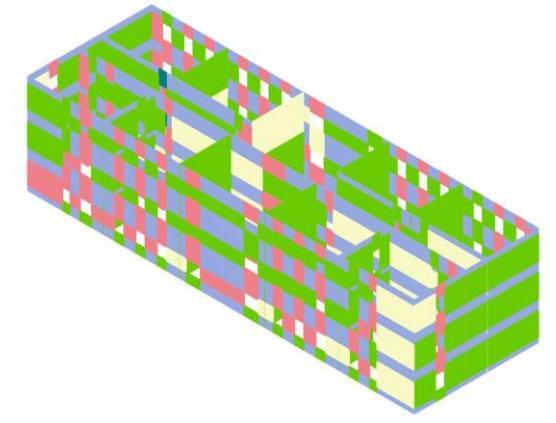
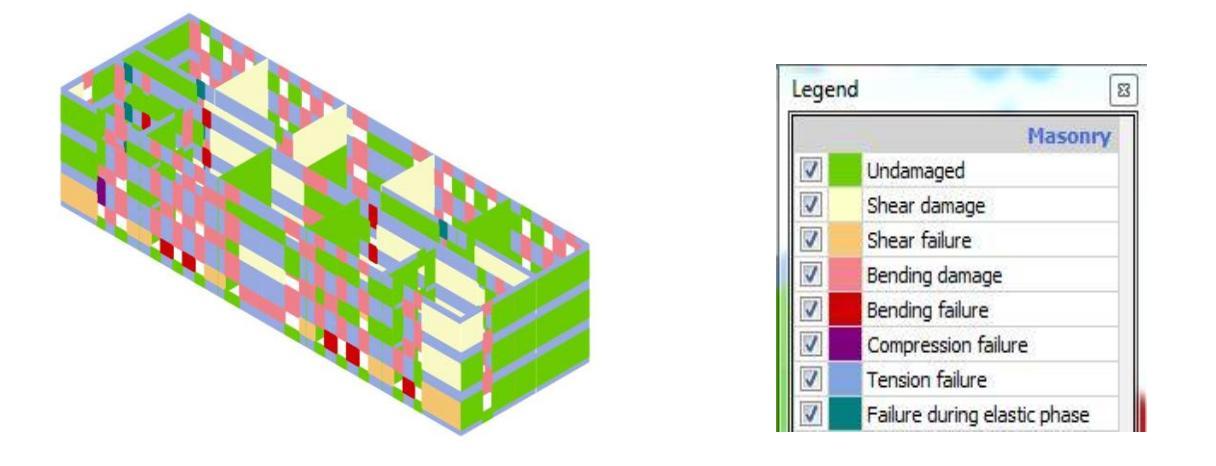
Figure 9. Damage limit state levels according to EC 8 under pushover x- direction.

Due to the low material quality and consequently the insufficient amount of stiffness, school building's seismic capacities in both directions are relatively small compared to the similar buildings for this type. Pushover analyses results and the damage patterns observed during the damage inspection confirms the induced damage during the November 26, 2019 earthquake for the school building.
