Numerical study to evaluate the structural response of the basilica of St. Sotiri

Hüseyin Bilgin, Zelina Fule, Hayri B. Özmen

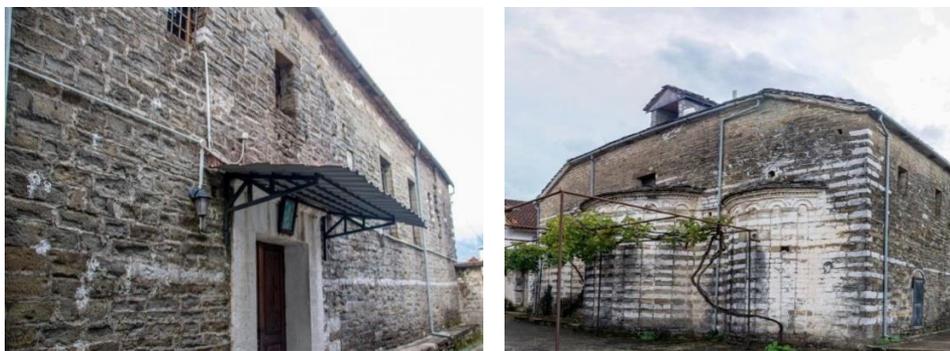
Photo 1. Church of the St. Sotiri's Basilica

It is one of the most remarkable religious monuments in the Gjirokastra district and is a type of three aisled barrel-vaulted basilica composed of the nave, the altar and the sanctuary which are composed in the same space dating back to the 17th-18th century. Firstly, current conditions of the structure are examined by in-situ inspection. Secondly, a global analysis of the structure has been prepared by utilizing the finite element (FE) modelling method. Then, the obtained results were compared with the visual inspection observations made on the load-bearing components of the church. It is believed that the findings could provide a case study that expands the understanding of the structural behavior of this structure typology. Considering its historical value, building developments, public and religious status make this study an important and interesting issue.

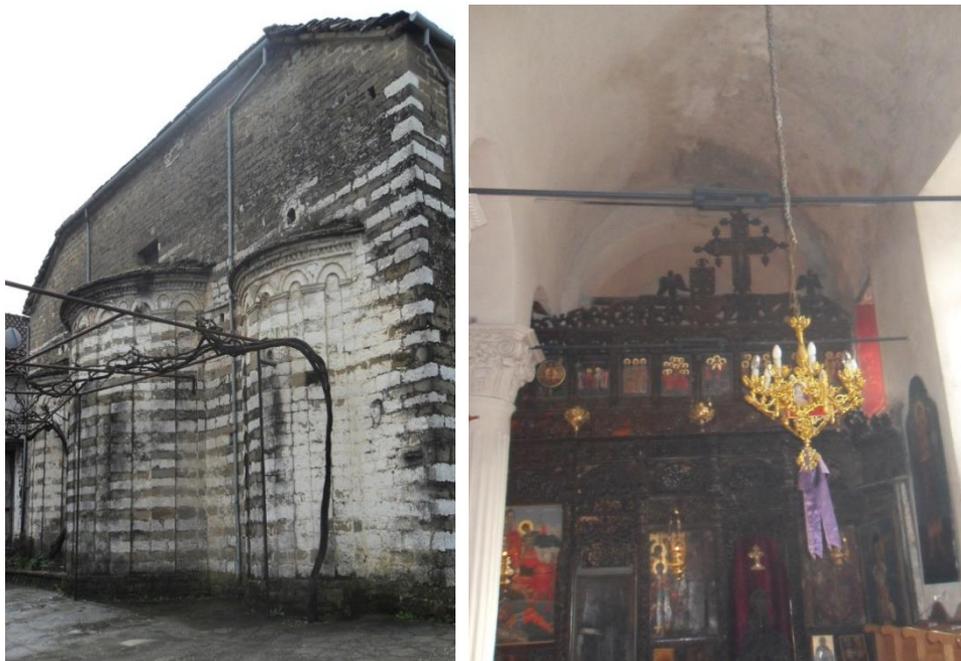
Figure 2. a) East view of the Basilica; b) Iconostasis

This study aims to assess the structural response of the church of the St. Soitiri’s Basilica (Figure 2). Current situations of the church were studied by in-situ survey. The church is a three aisled barrel-vaulted basilica, with inner dimensions of 15.75 x 12.10 m and it is

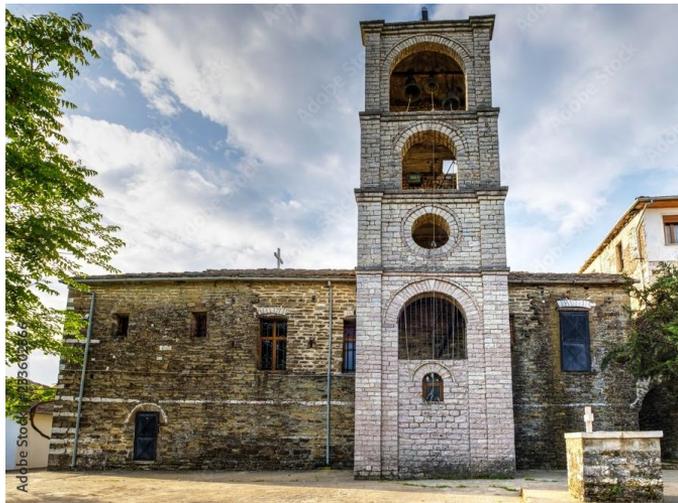
Photo 2. Church of the St. Sotiri's Basilica

In 1999 after an earthquake a slight misalignment and damage to the load-bearing walls occurred. The epicenter of the earthquake was 3.5 km from Gjirokastra, with a magnitude of 4.6 Richter scale and it is recorded by church authorities in basilica's archives. After repairing some parts of the load bearing walls of the basilica, it was added also the tower bell (Photo 2).

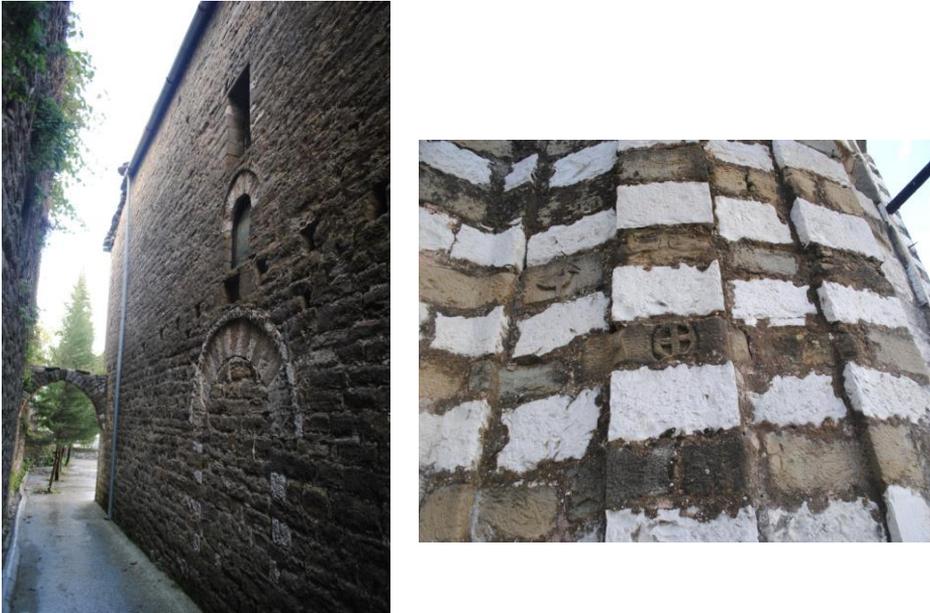
Figure 4. Western wall of the Basilica (left); Different colored stones, Eastern wall of the Basilica (right)

standing ancient masonry structures. There is no uniformity in the distribution of mortar (Figure 4). In some places it is totally missing, and it is noticed that these places are rebuilt lately (Figure 5).

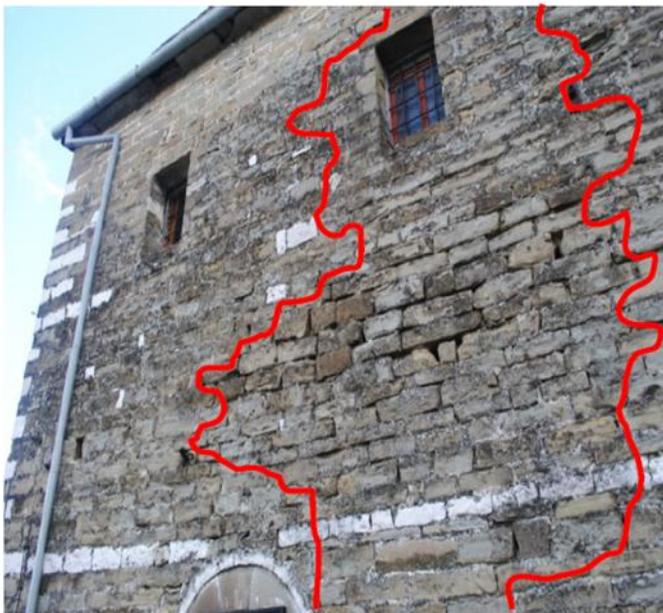
Figure 5. Northern wall

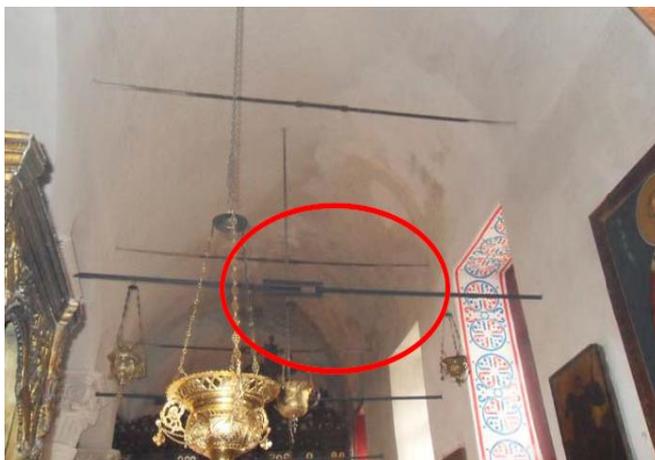
Figure 6. Barrel vault over the South aisle, moisture concentration

There are three main parallel barrel type vaults which are placed in East – West direction. Then there are two other barrel type vaults with smaller dimensions, constructed perpendicular to the main ones, placed in North - South direction. From the inspection it resulted that the moisture is a significant problem especially during the rainy season (Figure 6).

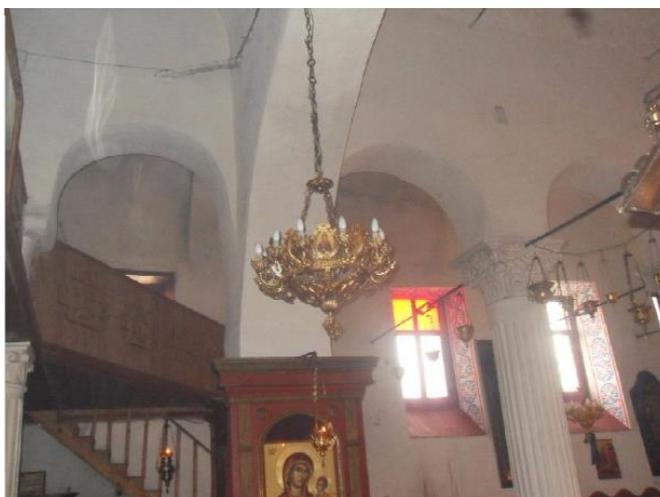
Figure 7. Narthex, Western side of the basilica

The narthex is composed of two floors inside the basilica, located at the west side (Figure 7). In St. Sotiris Basilica the narthex is composed of two floors constructed with timber beams in the west side of the basilica and it is separated from the nave by a series of arches.
