## **Performance of masonry structures during the 2009 L'Aquila (Italy) earthquake**

KAPLAN, H.<sup>1</sup>; BILGIN, H.<sup>2</sup>; BINICI, H.<sup>3</sup>; YILMAZ, S.<sup>4</sup>; OZTAS A.<sup>5</sup>

**Keywords:** L'Aquila earthquake, unreinforced masonry, historical buildings, failure, collapse.

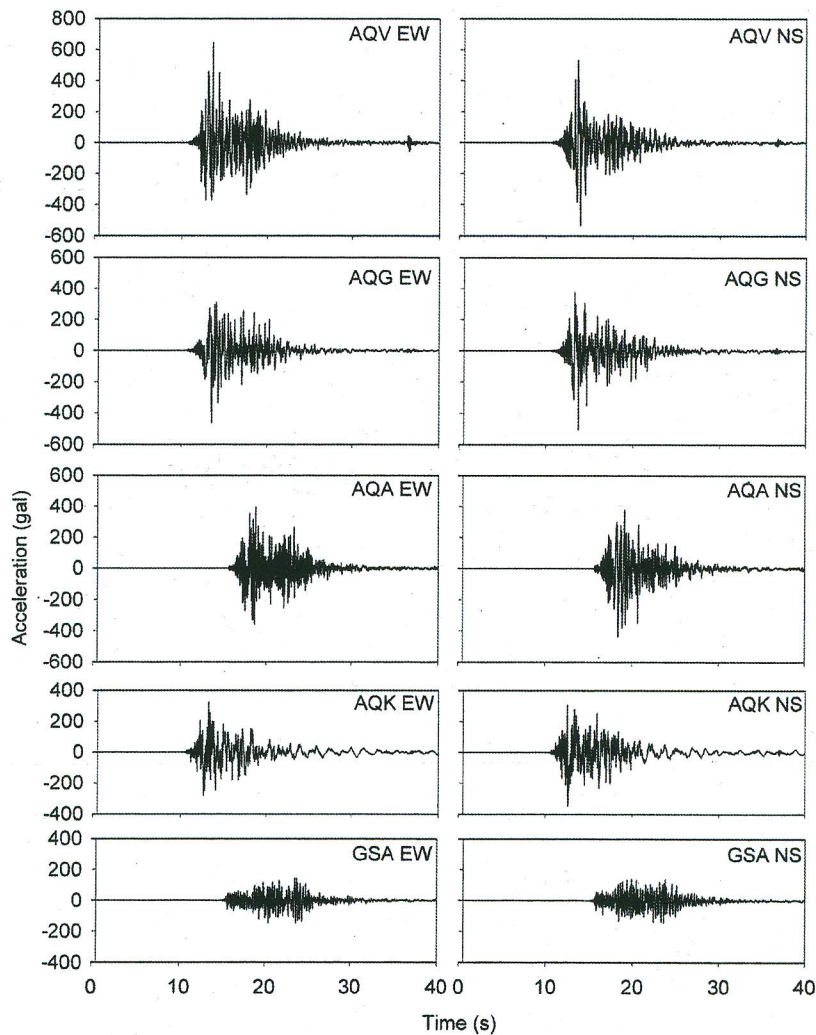
**Figure 1.** Corrected acceleration records for stations with  $\text{PGA} > 0.1g$  (time not synchronized)

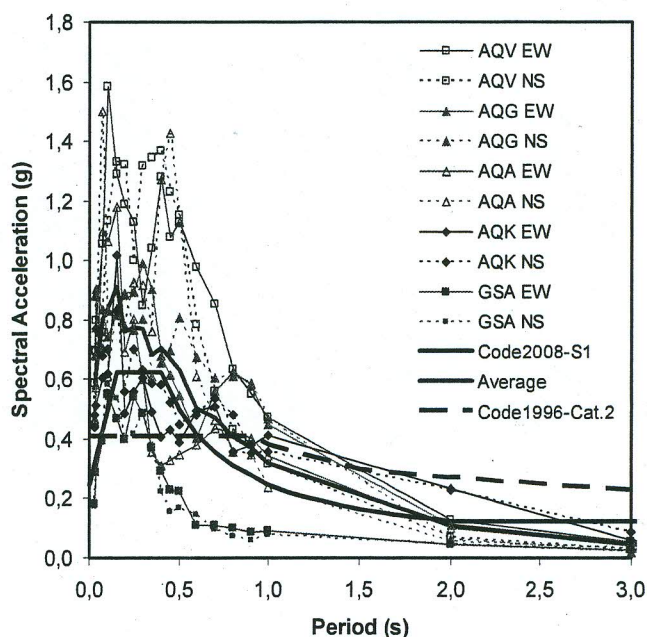
Figure 2 compares spectral acceleration values of each record and the average of them with the current design spectrum of the Italian Code (NTC2008) for rock type soils and that of 1996 Code for Category 2. The current code has greater spectral accelerations with respect to the older code. However, most of the buildings were not designed per 2008 code. Moreover, many of the buildings were non-engineered. Nevertheless, response spectrums have much higher acceleration values than both codes especially for periods less than 1.0s. This figure clearly shows that buildings were exposed to seismic forces higher than expected design forces. The average spectrum of 10 strong motion components almost doubles the spectrum of 1996 code for  $T < 0.5s$ .

**Figure 2.** Response spectra of records of 5 stations for 5% damping and comparison with NTS design spectrum

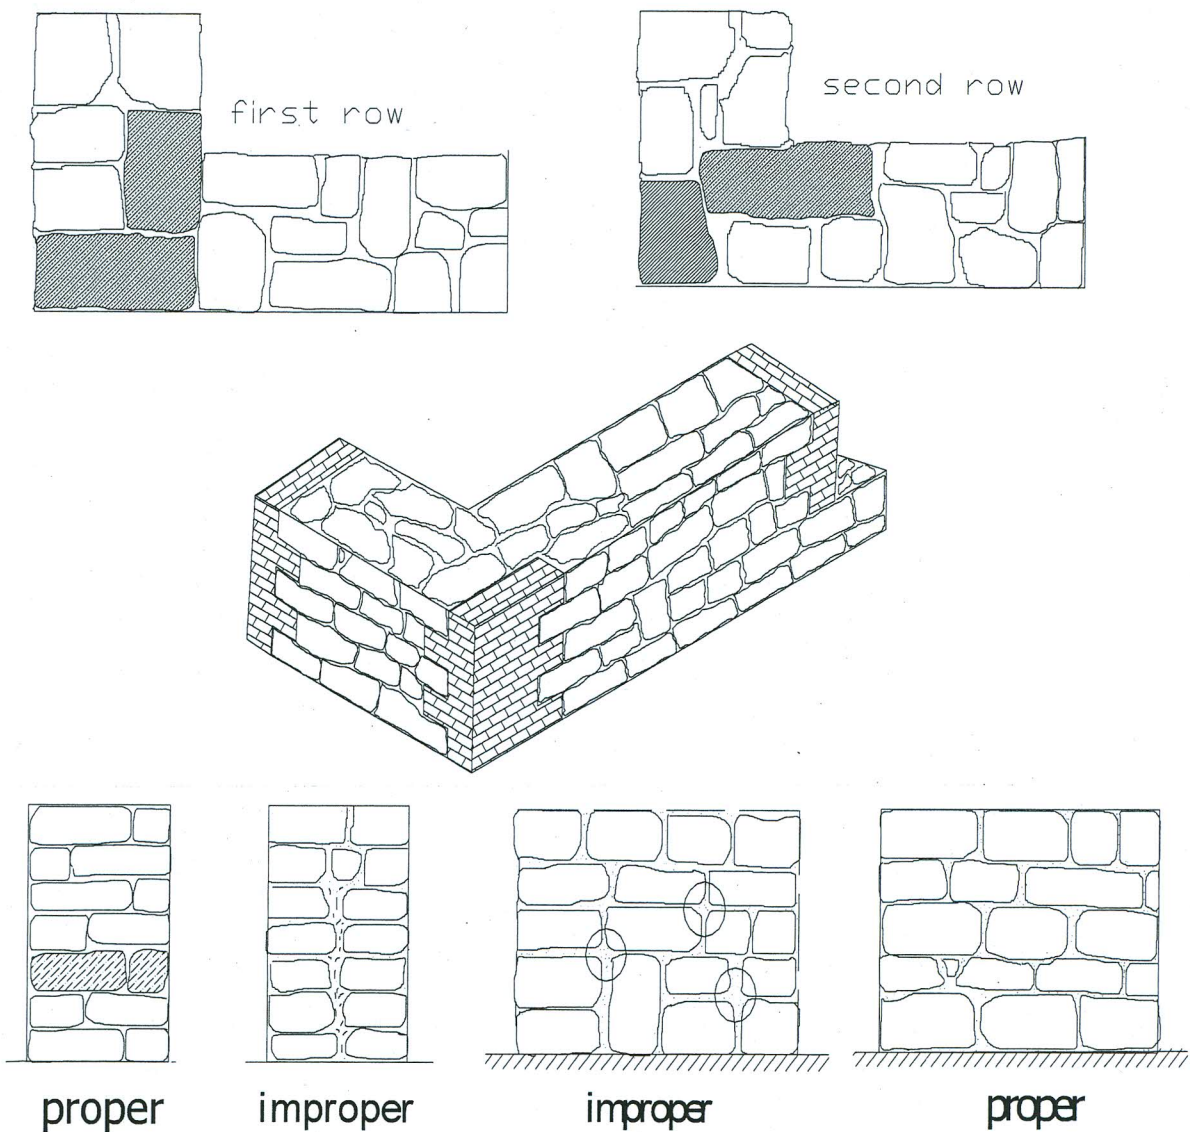
**Figure 7.** Typical interlocking of masonry units

Masonry wall construction involves the laying of brick, concrete block, or stone in beds of mortar, the installation of accessory items, and sometimes reinforcement. One of the most important things is that masonry units should be placed to interlock with each other and satisfy a proper connection between crossing walls. Typical interlocking of masonry units are shown in Fig. 7.

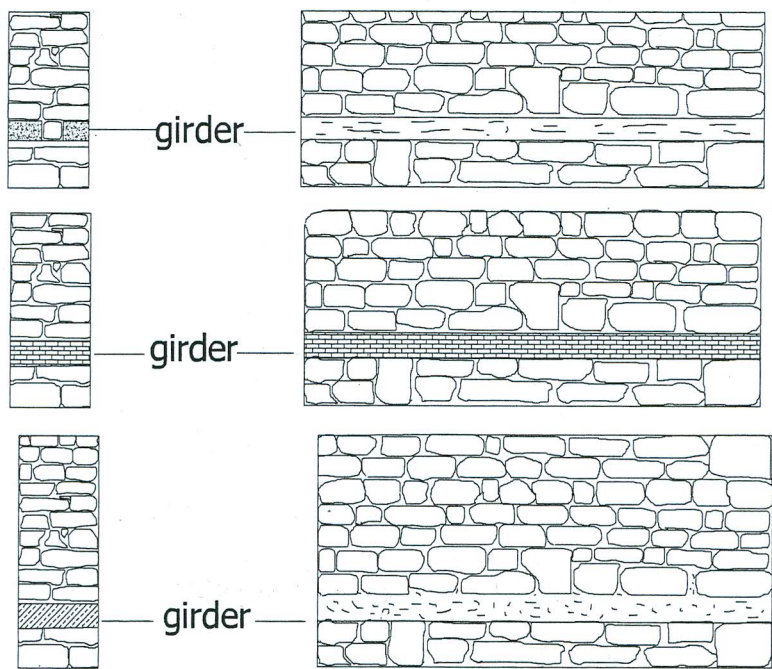
**Figure 8.** Bonding beams (girders) in URM walls a) Wood, b) Brick c) Reinforced Concrete

Bonding beams are also important elements to satisfy the integrity of the walls. They can be either constructed from wood or reinforced concrete (Figure 8). It is always better to confine concrete with horizontal and vertical bonding elements. However, it is very crucial to construct horizontal beams.
