Research Article

## Influence of material properties on the seismic response of masonry buildings

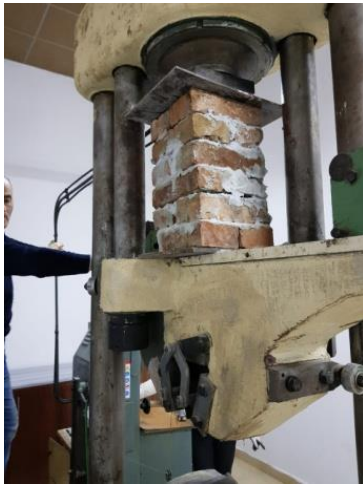
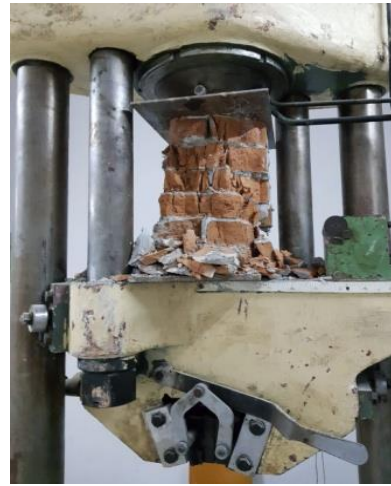
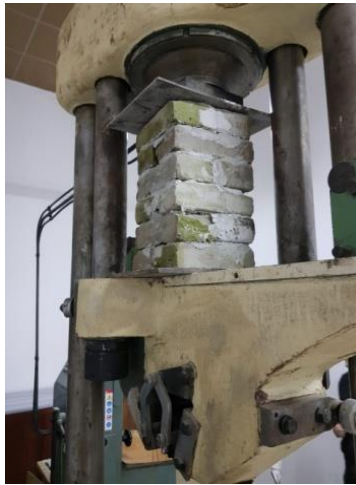
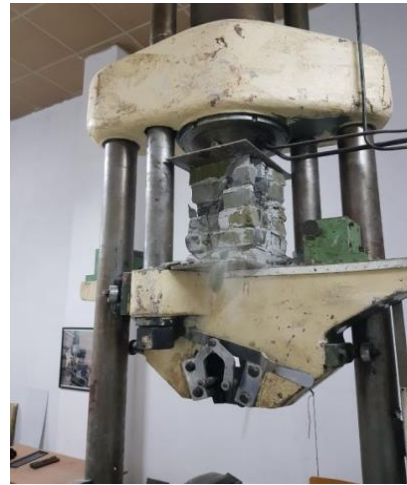
Fig. 3 Masonry prism tests (a-b); Red clay brick samples under compression and silicate brick test (c-d)

Six masonry prisms produced by silicate and clay bricks were tested (Fig 3.) in compression in the direction perpendicular to the horizontal bed-joints, according to EN 1052-1 [20]. Specimens of both types of masonry were also subjected to the shear test for the determination of the initial shear strength ( $f_{v0}$ ) and the friction coefficient ( $\mu$ ), according to the guidelines given by EN 1052-3 [20].

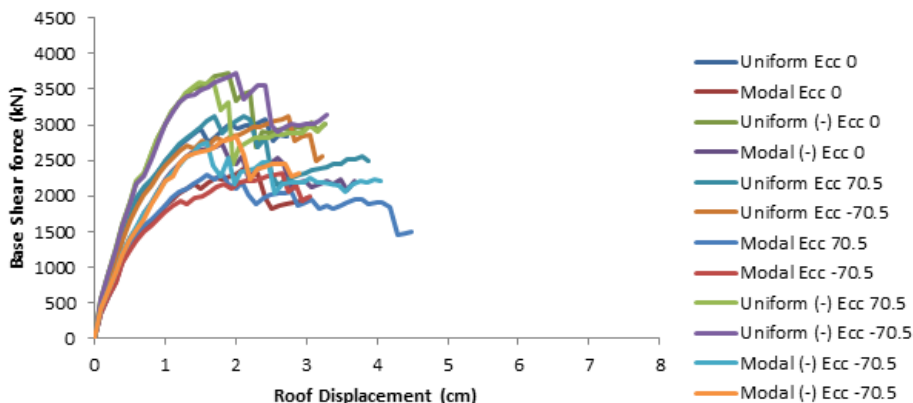
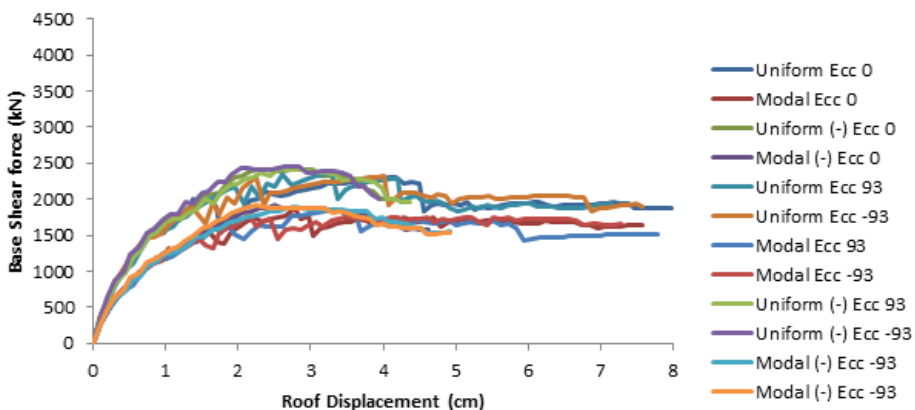
Fig 5. Capacity curves for clay brick masonry buildings

Upon completing the analytical modeling process, the pushover curves of the clay and silicate brick buildings were determined by carrying out nonlinear static analysis in TREMURI (Fig 5-6.). For the scope of the analyses, lateral load distribution proportional with the mode shapes were applied to the mass center of each storey considering the seismic weight. Seismic weight of the masonry buildings was calculated by considering the combination of Dead (G) and Live (Q) loads ( $G + 0.3 Q$ ).

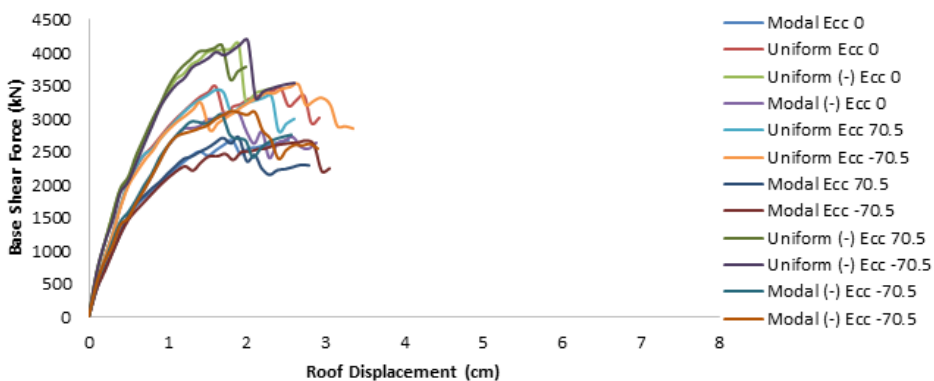
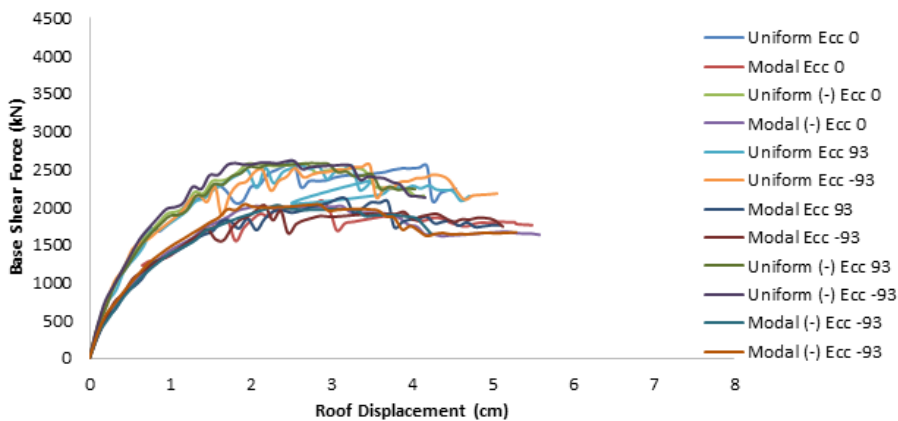
Fig 6. Capacity curves for silicate masonry building

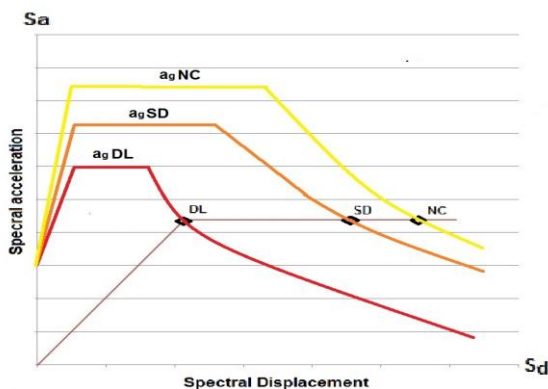
Fig 7. Schematized Calculation of “a<sub>g</sub>” for different damage limit states levels (simplified figure)

Subsequently, following the outlined criteria in Eurocode 8, Part 3 damage limit states of the studied buildings were calculated, and seismic capacities were determined. The capacity evaluation of the investigated buildings was performed using Part 3 of Eurocode 8 [23]. Three limits states levels, i.e, “Damage Limitation (DL)”, “Significant Damage (SD)” and “Near Collapse (NC)” are defined for performance evaluation (Fig 7).
